Geological trail around the city centre of St. Albans

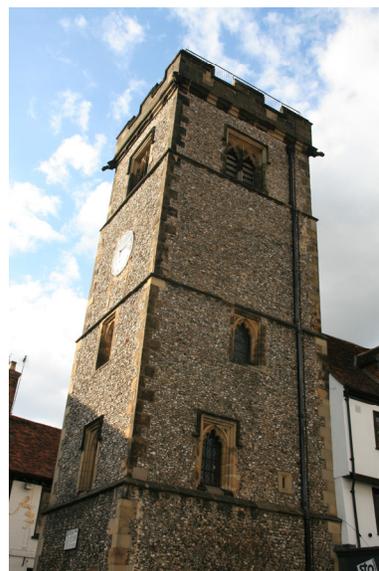
11th stop: Clock Tower, which is an early 15th Century curfew tower build mainly of dressed **flint** from the local Chalk, but with quoins of Carboniferous sandstone, probably a Coal Measure sandstone from the Bradford area, W. Yorkshire. Among the flints are also a few pieces of **Hertfordshire Puddingstone**. Note the way this hard rock has fractured; the silica matrix between the flint pebbles is so hard that the fracture surface has cut straight through the pebbles. The rock is from beds of sand and clay (the Reading beds) overlying the local Chalk; patches of flint pebbles were deposited within the Reading Beds by rivers and later became cemented by precipitation of silica between the pebbles. Because it is so hard, puddingstone can take a high polish and then shows a range of attractive colours. Turn right onto High Street.
